The Digging Deep Tour 2013

This is the story of a weeklong project to build a prototype septic tank, disposal system and toilet suitable for use by a small group of families. The ultimate goal was to develop a system that could be introduced across similar communities on a broader scale.

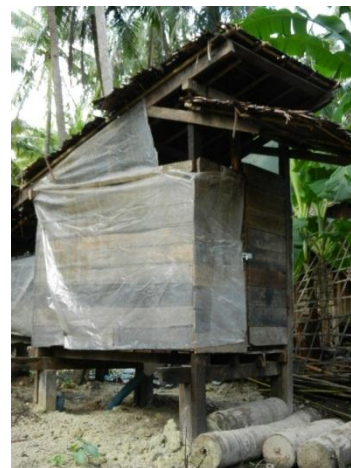
Where toilets presently exist, they discharge directly to an earthen pit (pictured right). In our opinion it is most likely that this practise is contributing to ground water contamination and some of the local health problems as the ground water is drawn from nearby wells for washing and drinking.

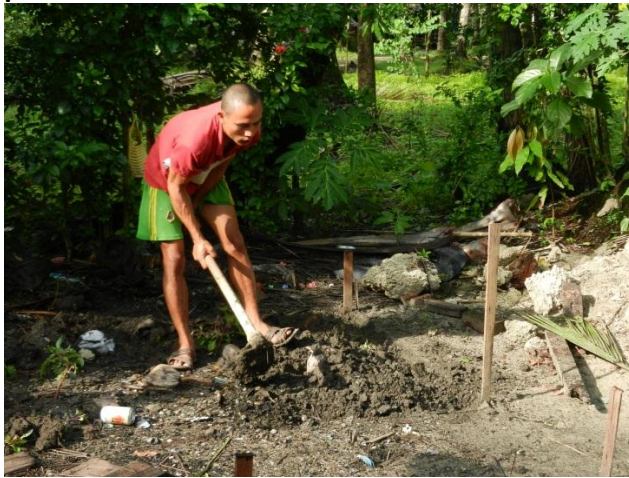
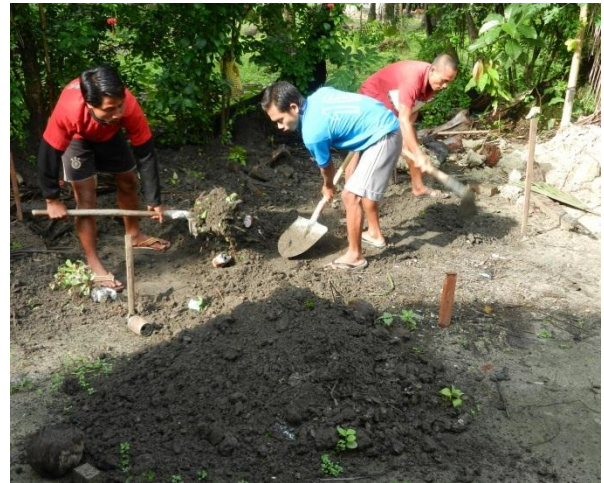
Day 3 - Septic tank hole excavated in trying conditions due to high ground water table just 750mm below surface level. Ground water constantly re-enters the excavation which was dug using a pick, shovel, hands and "wok". A portable petrol pump was secured to drain the hole and keep the excavation "dry". It ran continuously to enable the base slab to be poured and walls built.

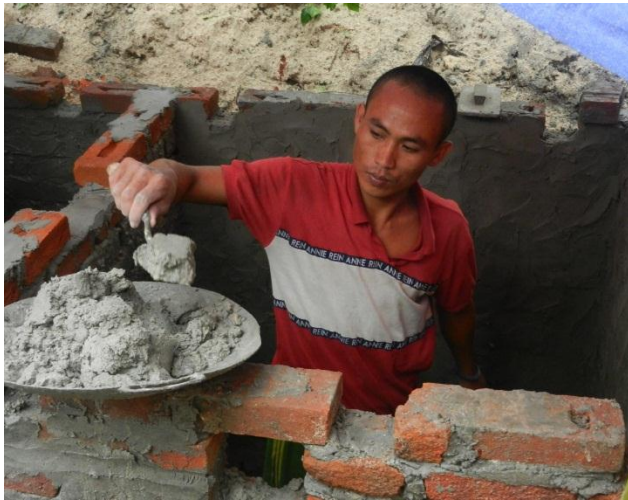
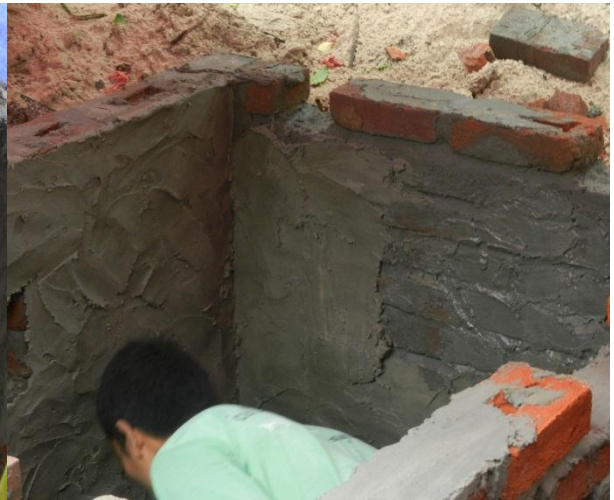
Rendering the septic tanks for water sealing with aid of the multi – purpose wok. It will probably cook tonight’s dinner too.

Day 5 – Rendering inside the septic tank for water tightness.

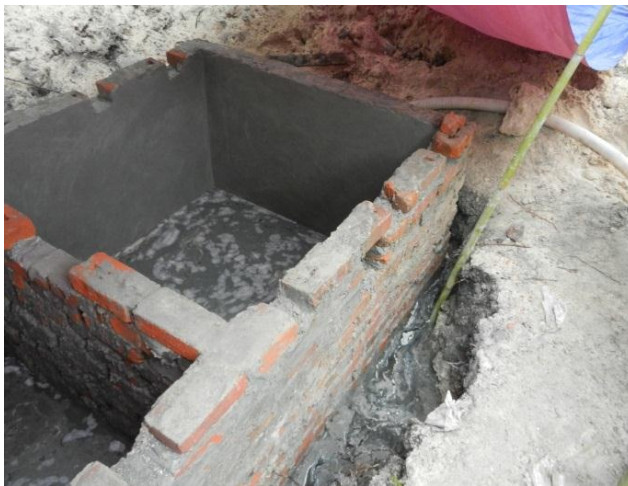
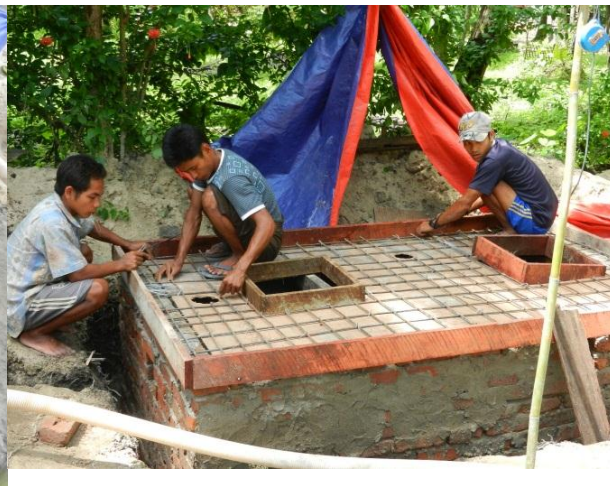
Fully rendered septic tank.

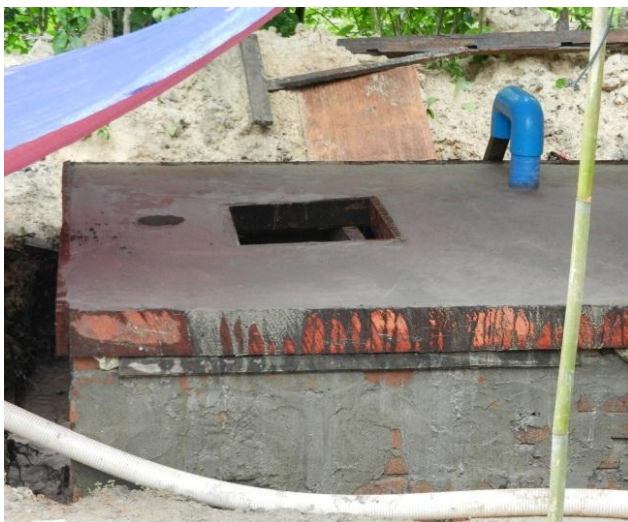
Lid poured.

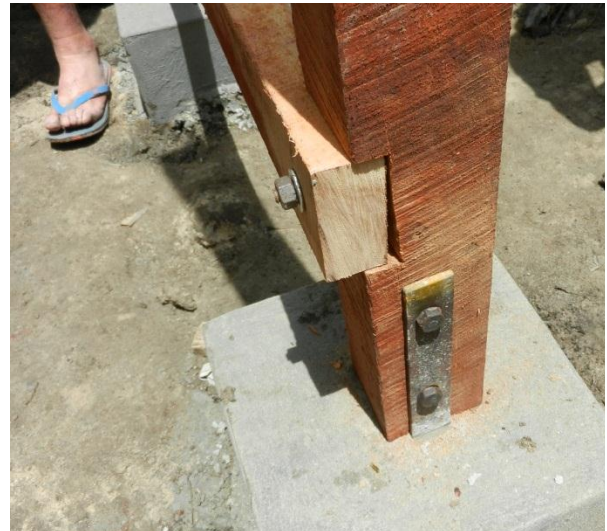
Posts bolted into position.

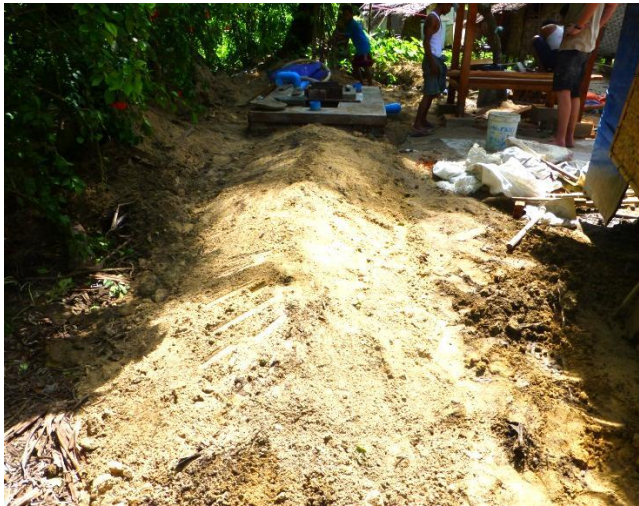
Trench backfilled .

Woven fabric to stop the pipe silting up, slotted pipe bedded in gravel and wrapped in fabric

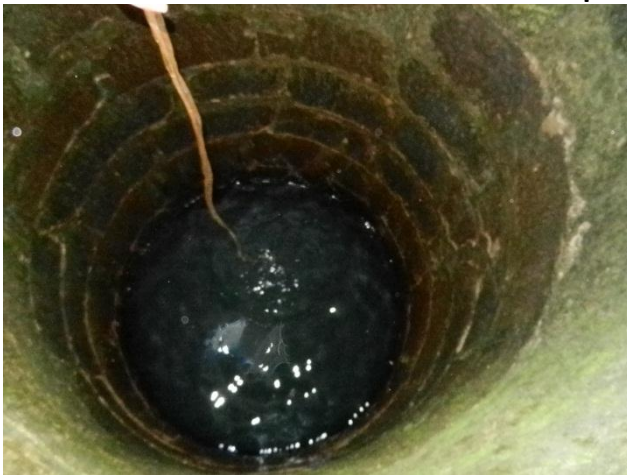
Water rises with tide as fresh water lens on top of saline water

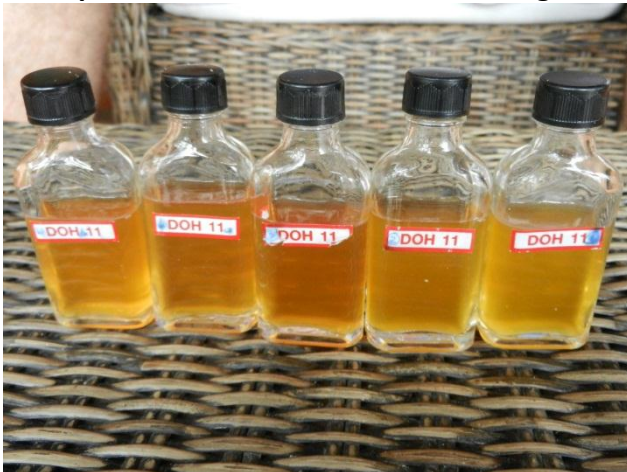
Water samples reacting with reagent

After prescribed period samples "unfit for human consumption" as colour guide
